**Level 1 Geotechnical Testing and
Inspection Authority Services
River Valley Estate Stage 7C East**

Prepared for
CJ Arms / Yourland

Prepared by
Tonkin & Taylor Pty Ltd

Date
2 November 2022

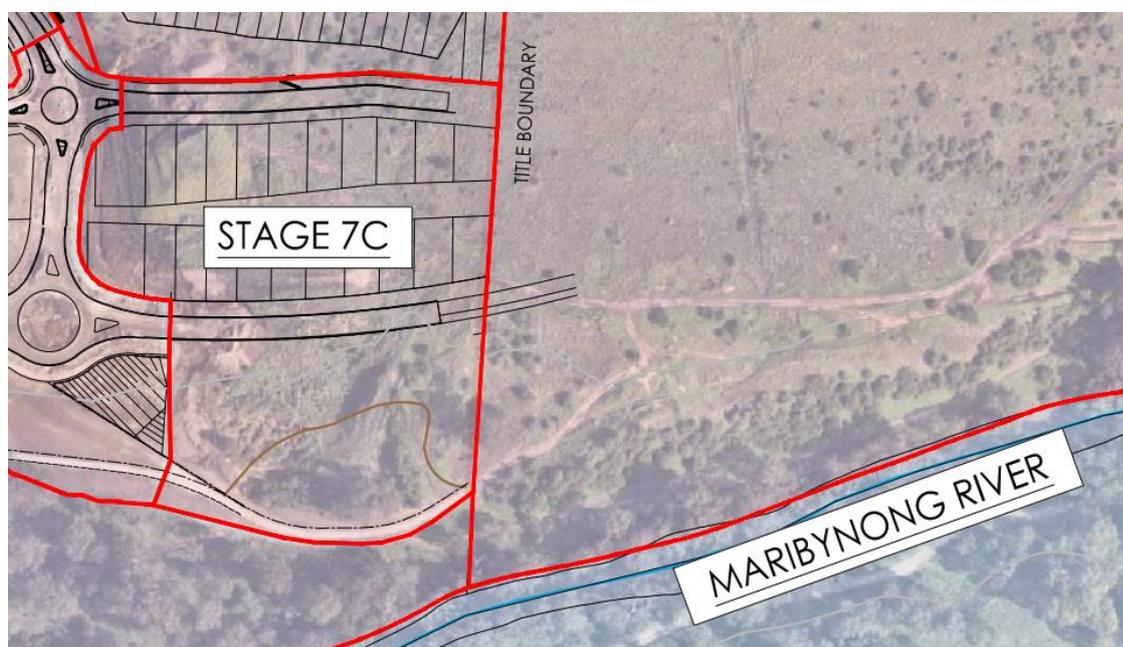
Figure 1: Stage 7C East (Reserve)– extract from CJ Arms drawing 'Overall Staging Plan'

The included works are shown on the Site Plans in Appendices A and D. Figure 1 below is an extract from the Overall Staging Plan prepared by CJ Arms provided at the time of writing this report.

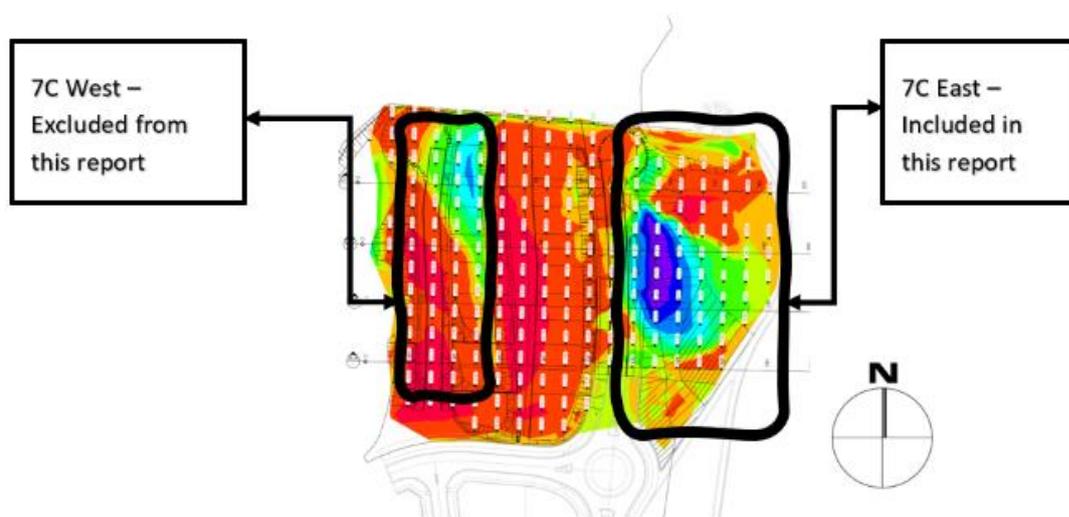
Figure 2: Heatmap provided by CJ Arms - Stage 7C East and 7C West areas

We note that as part of the 7C East earthworks, the adjacent area of Stage 7C West was also filled and supervised by Chadwick Geotechnics. The works for Stage 7C West will be covered in separate Level 1 GITA reports. The snapshot shown as Figure 2 indicated the general boundary of Stage 7C East and 7C West.

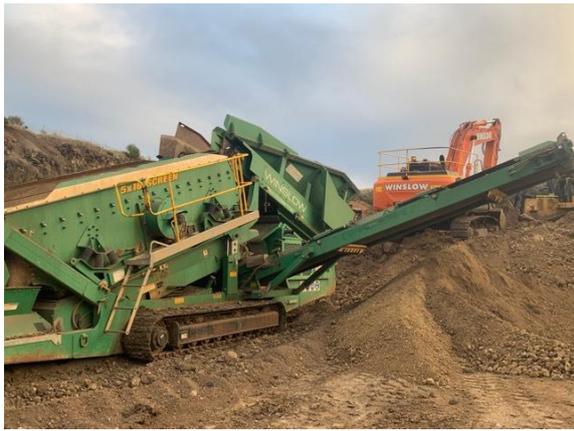
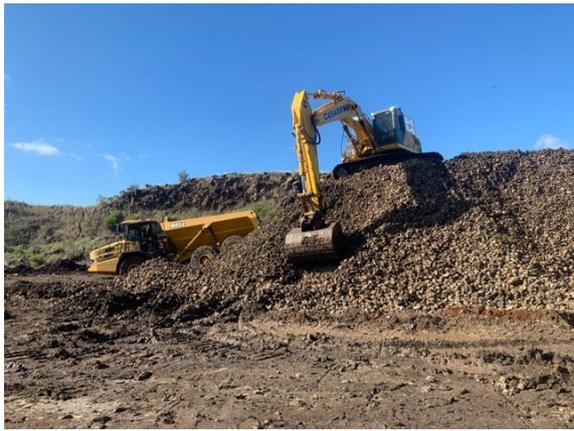
Figure 3: Earthwork plant used on site

- Screening plant – utilised in Stage 7D, preparing the source materials for use in Stage 7C.
- Excavator – utilised for removing the uncontrolled fill and topsoil from Stage 7C.
- Moxy trucks – utilised for moving the fill from the screened stockpiles in Stage 7D to the fill pads in Stage 7C, and for removal of the unsuitable soils from Stage 7C.
- Compactor – utilised for the compaction of the engineered fill.
- Water cart – used for moisture control of the engineered fill.

<p>Photo 1: Screening plant used in Stage 7D</p>	<p>Photo 2: Excavator and Moxy truck – loading screened fill material from Stage 7D</p>

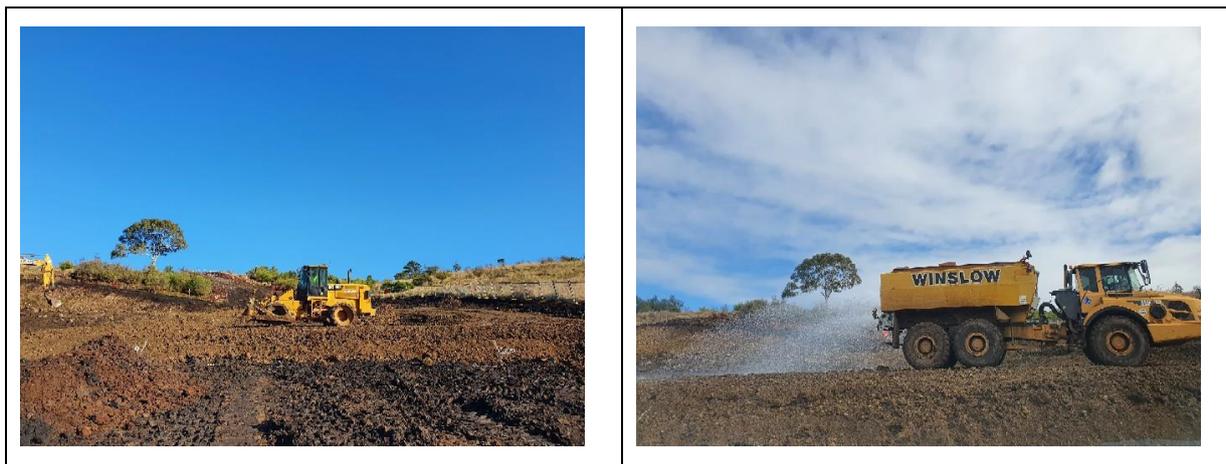
<p>Photo 3: Compactor used on Stage 7C</p>	<p>Photo 4: Water truck used on Stage 7C</p>

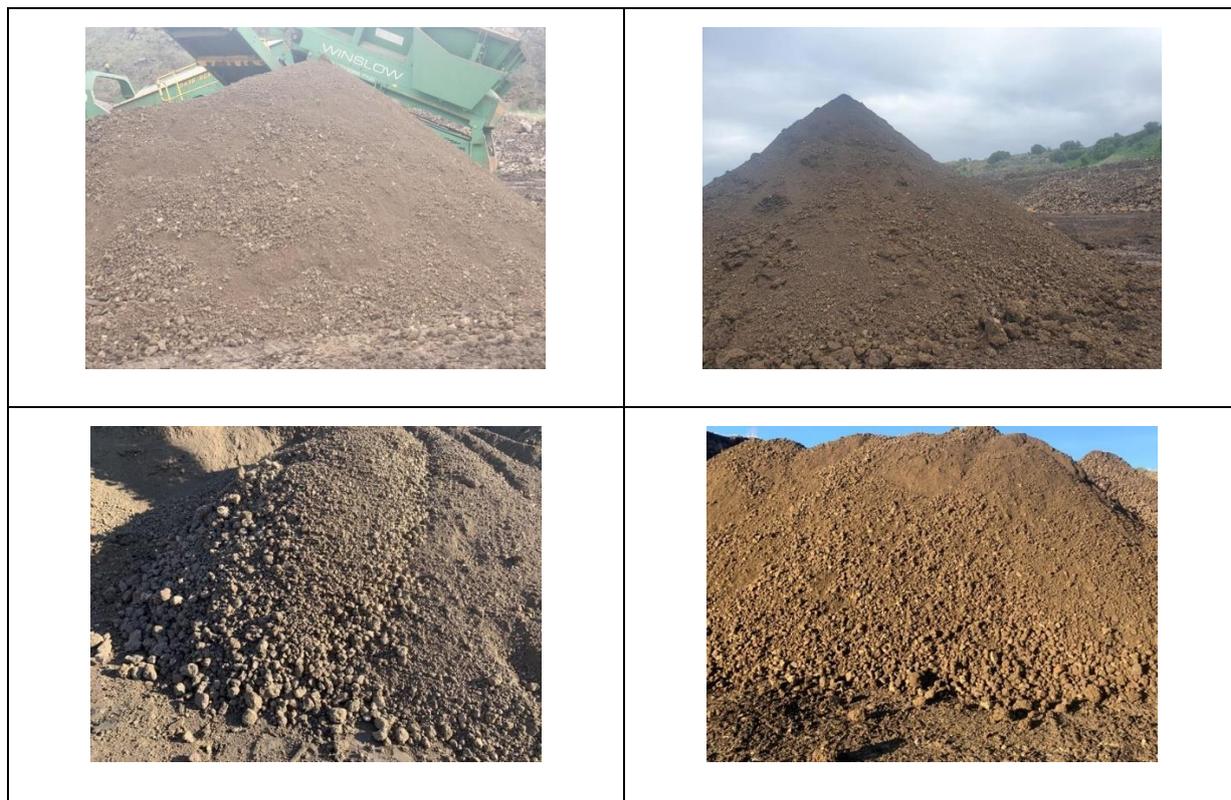
Figure 4: Photographs of the material used on site, screened in Stage 7D

Material used during the construction of the fill comprised of local gravel and silty clays won from the existing stockpiles within the adjacent Stage 7D. The materials were sorted and sieved through a 75mm screening plant in Stage 7D and brought by moxy trucks to the fill area in Stage 7C. The materials were assessed to meet the specified criteria for Type 2 engineering fill as per T&T Specifications.

Below are photographs of the sieved fill materials used during construction.

The soil is considered as 'Suitable Material' in accordance with Section 4.4 of the AS3798-2007.

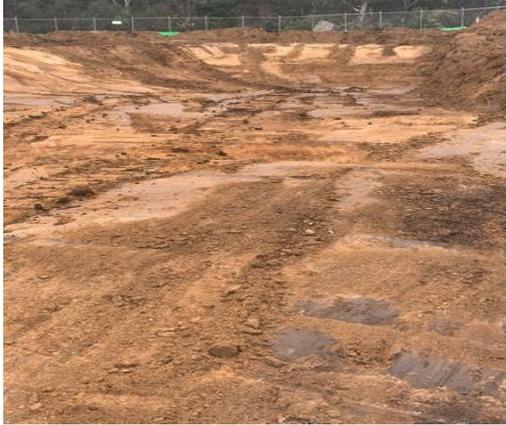
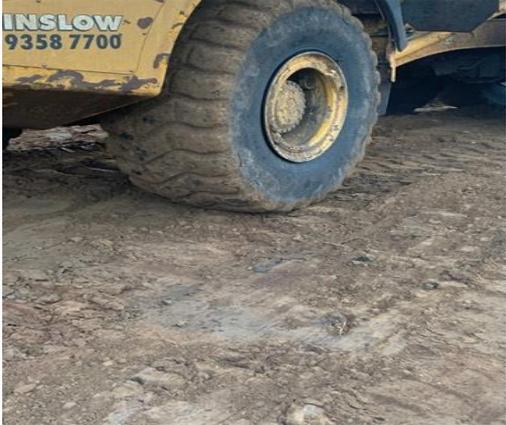
Figure 5: Subgrade assessment photographs

<p>Photo 1: Subgrade surface following removal of the uncontrolled fill</p>	<p>Photo 2: Proof roll using a loaded water truck</p>

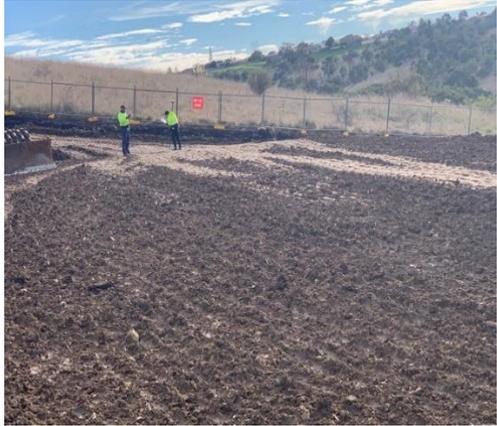
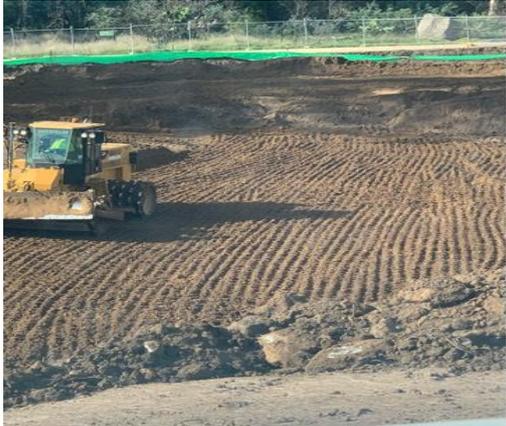
<p>Photo 3: Scarified subgrade surface prior to filling</p>	<p>Photo 4: Compaction of the scarified subgrade prior to filling</p>

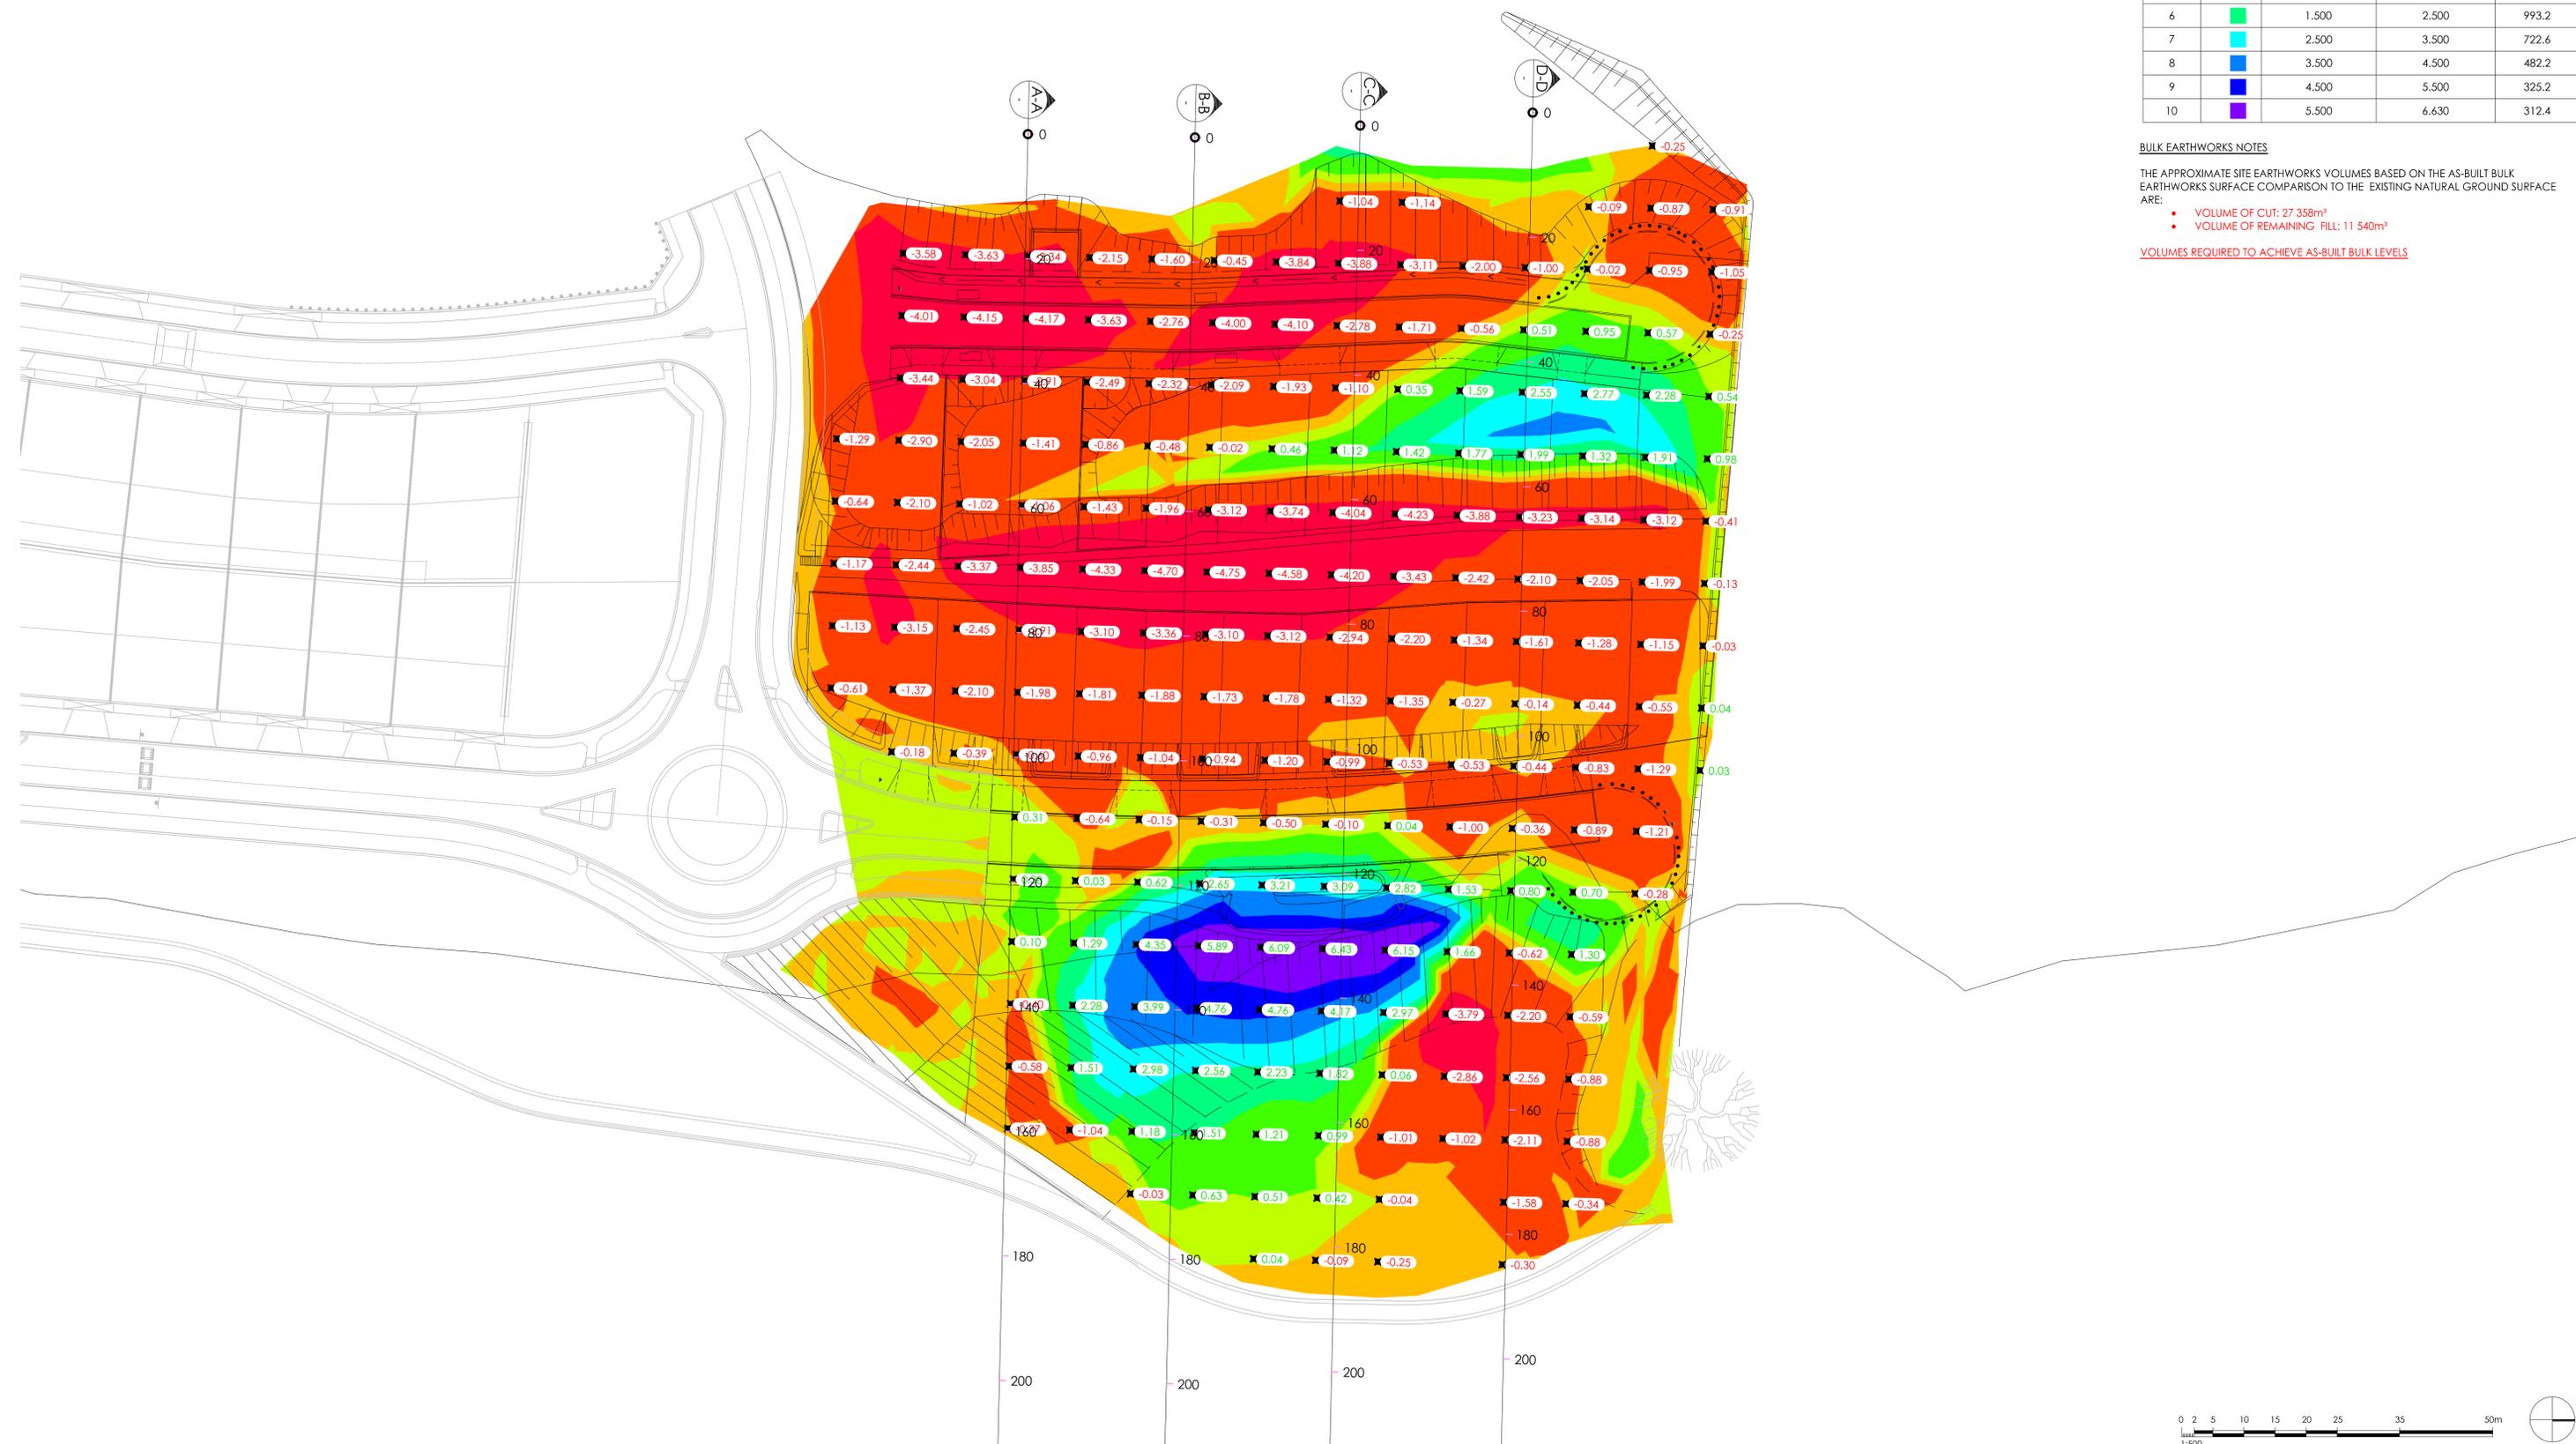
VOLUMES REQUIRED TO ACHIEVE AS-BUILT BULK LEVELS

- VOLUME OF CUT: 27 358m³
- VOLUME OF REMAINING FILL: 11 540m³
